# Safety Report

CHICHESTER COTTAGE

HOBSONVILLE NZ 0618

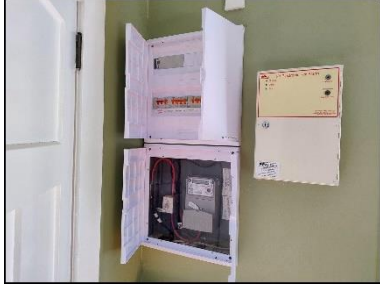
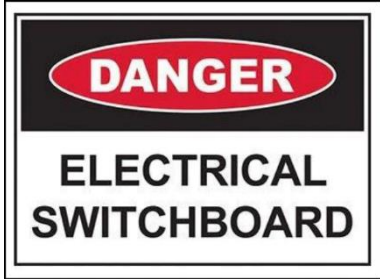
| Item | Observation & Recommendation | Photo | Risk Rating |
|---|---|---|---|
| 1.1 Switchboards | <p>Noted no signage on switchboard.</p> <p>We recommend that the switchboard is clearly marked with appropriate signage stating, "SWITCHBOARD".</p> <p><b>Trade:</b> Handyperson<br/>(AS/NZS 3000:2018 Clause 2.10.2.4)</p> | <p>Example:</p> | Comment Only |

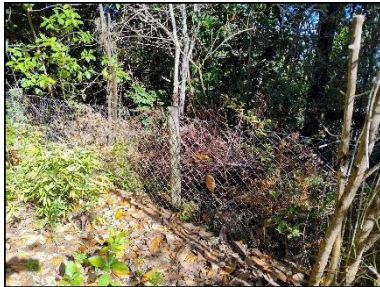
| Item | Observation & Recommendation | Photo | Risk Rating |
|---|---|---|---|
| 2.1 Rear fencing | <p>We noted well-maintained fencing posing no apparent or sufficient hazard at the time of inspection.</p> <p>We recommend ensuring the fencing remains in good condition.</p> <p>(AS/NZS ISO 31000:2009; NZBC cl F4, cl D1 ; Building Regulations 1992; Fencing Act 1978)</p> | | Meets Best Practice |

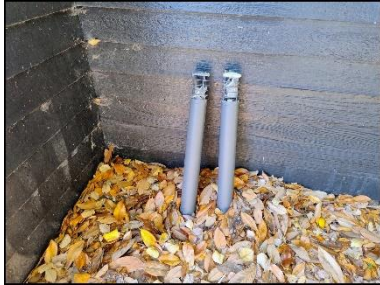
| Item | Observation & Recommendation | Photo | Risk Rating |
|---|---|---|---|
| 3.1 Rear of house | <p>We noted waste that represents a health / personal injury hazard.</p> <p>We recommend cleaning the area as soon as possible.</p> <p><b>Description:</b> Old lighting bollards left behind the house.</p> <p><b>Trade:</b> General Maintenance</p> <p>(AS/NZS ISO 31000:2009; NCBC c/ D1)</p> | | Comment Only |

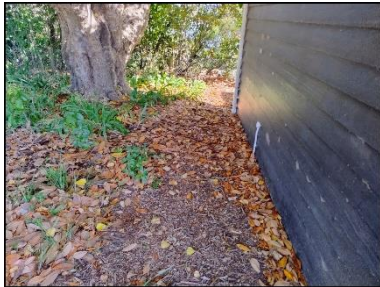
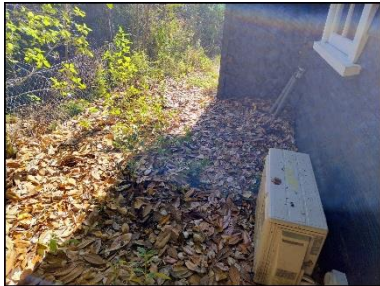
| Item | Observation & Recommendation | Photo | Risk Rating |
|---|---|---|---|
| 3.2 Rear of the cottage | <p>We noted old leaves that have built up and represent a health / personal injury hazard.</p> <p>We recommend cleaning the area as soon as possible.</p> <p><b>Description:</b> Fallen leaves have built up around the side and rear of the cottage. These will decompose and become slippery in the winter months.</p> <p><b>Trade:</b> Gardener</p> <p>(AS/NZS ISO 31000:2009; NCBC c/ D1)</p> | <br> | Comment Only |

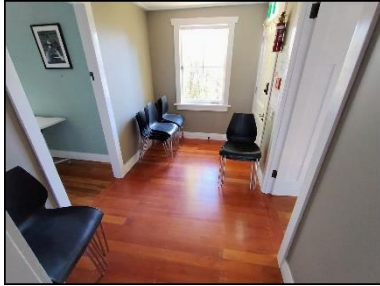
| Item | Observation & Recommendation | Photo | Risk Rating |
|---|---|---|---|
| 3.3 Foyer | <p>We noted untidy surroundings that represent a tripping / personal injury hazard.</p> <p>We recommend storing the chairs in a different area of the cottage as soon as possible.</p> <p><b>Description:</b> Chairs stored in the entrance of the cottage</p> <p><b>Trade:</b> General Maintenance</p> <p>(AS/NZS ISO 31000:2009; NCBC cl D1)</p> | | Minor |

| Item | Observation & Recommendation | Photo | Date actioned |
|---|---|---|---|
| 3.3 | We recommend storing the chairs in a different area of the cottage as soon as possible. | <br>Foyer | |

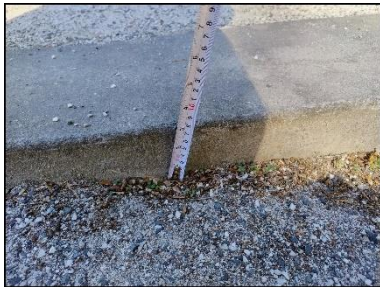
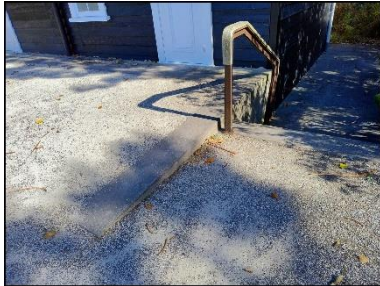
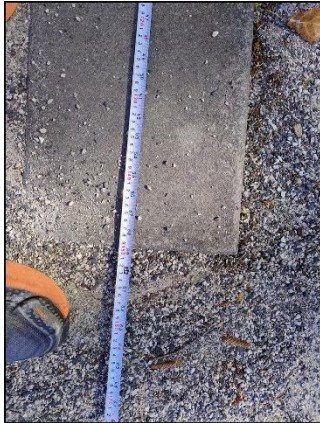
| Item | Observation & Recommendation | Photo | Risk Rating |
|---|---|---|---|
| 4.1 Top of stairs/corner of courtyard | <p>We noted unhighlighted kerbing that represents a tripping hazard.</p> <p>We recommend highlighting the top edge of the kerbing with yellow or contrasting, non-slip road marking paint as soon as possible.</p> <p><b>Length:</b> 1500mm</p> <p><b>Trade:</b> Handyperson</p> <p>(AS/NZS ISO 31000:2009; NZBC cl D1)</p> | | Minimal |

| Item | Observation & Recommendation | Photo | Date actioned |
|---|---|---|---|
| 4.1 | We recommend highlighting the top edge of the kerbing with yellow or contrasting, non-slip road marking paint as soon as possible. | <br>Top of stairs/corner of courtyard | |

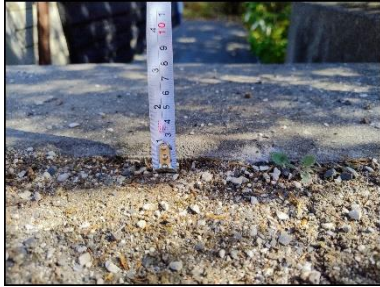
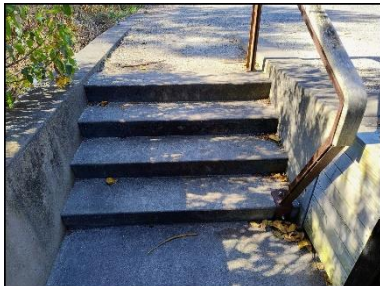
| Item | Observation & Recommendation | Photo | Risk Rating |
|---|---|---|---|
| 4.2 Concrete Stairs | <p>Noted that the earth is below the adjacent surface. This represents a tripping / personal injury hazard. People often twist their ankles or fall as a result of stepping across two uneven surfaces.</p> <p>We recommend filling the earth level with the adjacent surface as soon as possible.</p> <p><b>Average Depth:</b> 10mm-20mm</p> <p><b>Description:</b> surface leading to stairs slightly below the concrete stairs.</p> <p><b>Trade:</b> Handyperson</p> <p>(AS/NZS ISO 31000:2009; NZBC cl D1)</p> | | Minimal |

| Item | Observation & Recommendation | Photo | Date actioned |
|---|---|---|---|
| 4.2 | We recommend filling the earth level with the adjacent surface as soon as possible. | <br>Concrete Stairs | |

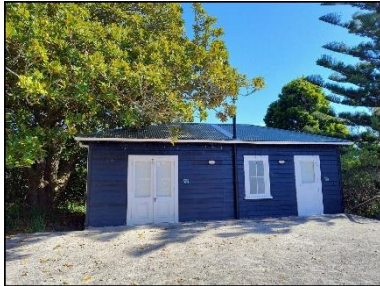
| 5.1 Working at Heights | <p>An Approved Safe Work Method Statement/Permit is required prior to commencing work, demonstrating care around working at heights</p> <p><b>Trade:</b> Administration</p> <p>(Safe Work Methods)</p> | | Comment Only |

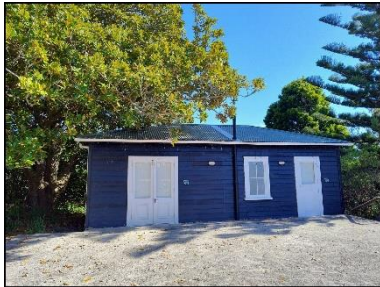
| 5.2 Confined Spaces | <p>An approved Safe Work Method Statement / Confined Spaces Permit is required prior to work commencing in confined spaces, demonstrating care whilst successfully meeting AS2865</p> <p><b>Trade:</b> Administration</p> <p>(Safe Work Methods)</p> | | Comment Only |

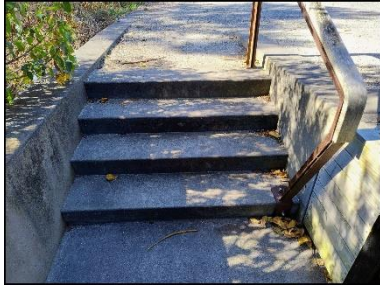
| Item | Observation & Recommendation | Photo | Risk Rating |
|---|---|---|---|
| 6.1 Stairs | <p>We noted that no anti-slip strips were present on the stairs. This represents a personal injury hazard.</p> <p>We recommend installing yellow or contrasting anti-slip strips as soon as possible.</p> <p><b>Number of steps:</b> 4</p> <p><b>Trade:</b> Handyperson</p> <p><i>(NZBC D1; Building Regulations 1992)</i></p> | | Comment Only |

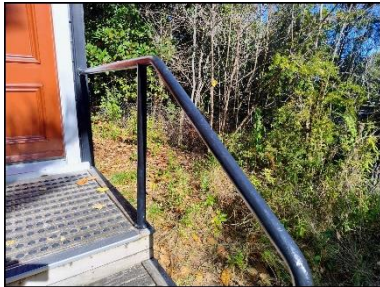
| Item | Observation & Recommendation | Photo | Risk Rating |
|---|---|---|---|
| 6.2 Back Door | <p>The handrail is loose and represents a personal injury hazard</p> <p>Repair the handrail</p> <p><b>Trade:</b> Handyperson</p> | | Minor |

| Item | Observation & Recommendation | Photo | Date actioned |
|---|---|---|---|
| 6.2 | Repair the handrail | <br>Back Door | |

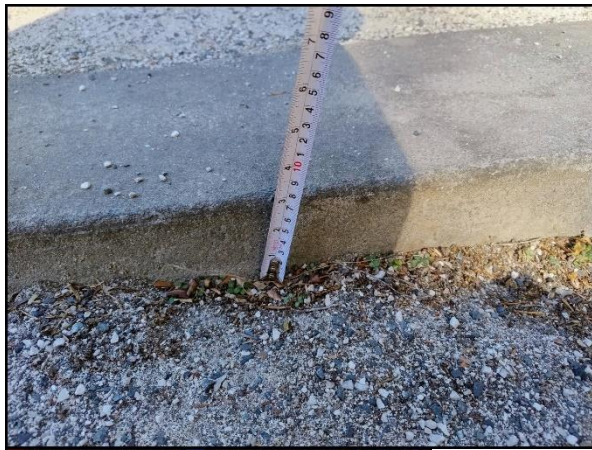
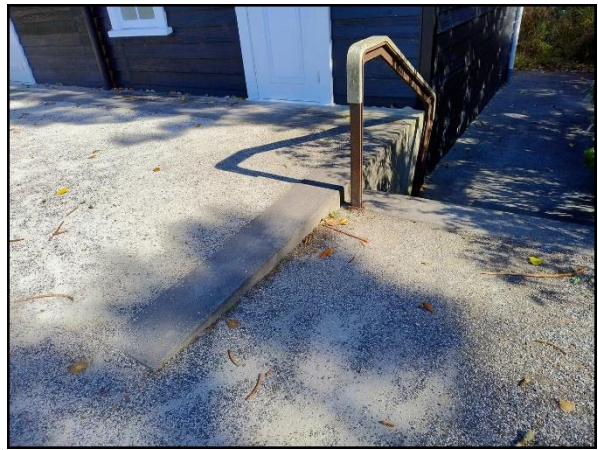
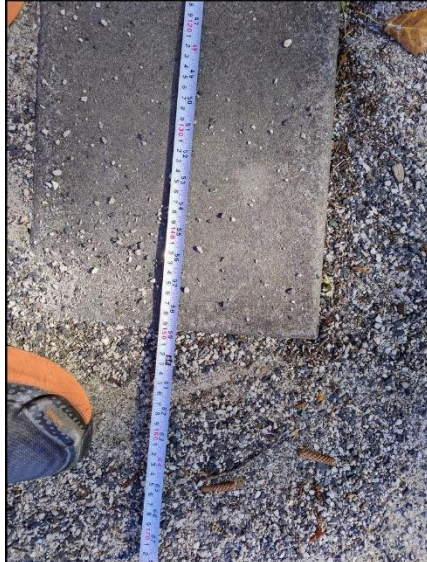
| <b>Location</b> | Top of stairs/corner of courtyard |

| <b>Observation</b> | We noted unhighlighted kerbing that represents a tripping hazard. |

| <b>Length</b> | 1500mm |

| <b>Work to be done</b> | We recommend highlighting the top edge of the kerbing with yellow or contrasting, non-slip road marking paint as soon as possible. |

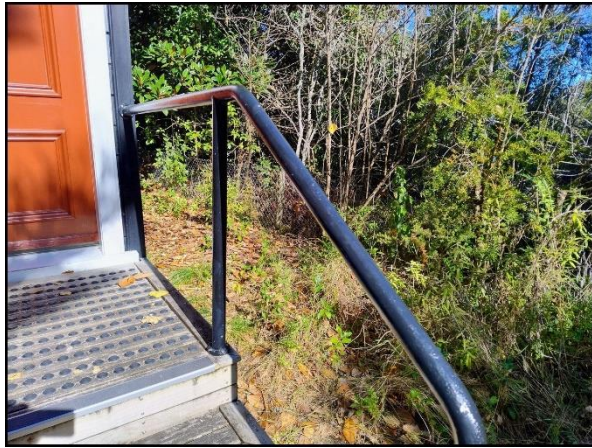
| <b>Location</b> | Back Door |

| <b>Observation</b> | The handrail is loose and represents a personal injury hazard |

| <b>Work to be done</b> | Repair the handrail |

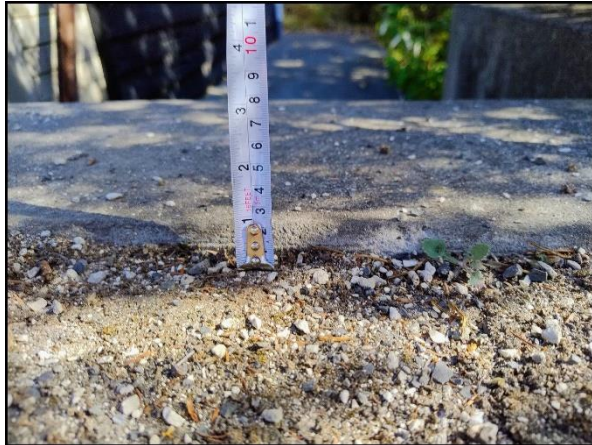
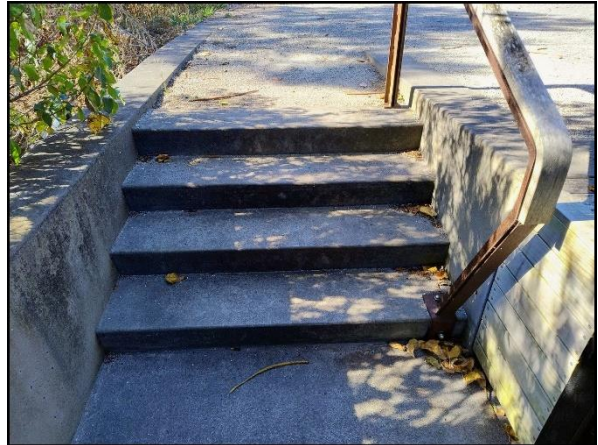
| <b>Location</b> | Concrete Stairs |

| <b>Observation</b> | Noted that the earth is below the adjacent surface. This represents a tripping / personal injury hazard. People often twist their ankles or fall as a result of stepping across two uneven surfaces. |

| <b>Average Depth</b> | 10mm-20mm |

| <b>Work to be done</b> | We recommend filling the earth level with the adjacent surface as soon as possible. |
